MINE SITE VISIT REPORT
New Mexico AML Program

Date of Visit : December 6, 2007 **Weather :** Cloudy 45°
Mine/Project Name: Davenport Mine – Northwest of Grants, New Mexico
Duration of Visit : 0.5 hour (1:15 pm to 1:45 pm)
Purpose of Visit : Maintenance inspection to the Davenport mine, part of the legacy site assessment for AML project sites.
Observations : Travel to the project site; access to this site was from the west using a two track road. Location: T.13N., R.9W., Sec. 20, NW1/4, NW1/4, SW1/4, Dos Lomas Quad. UTM Zone 13, N3914300 E243640; Uranium Mine. This site is on BLM land.

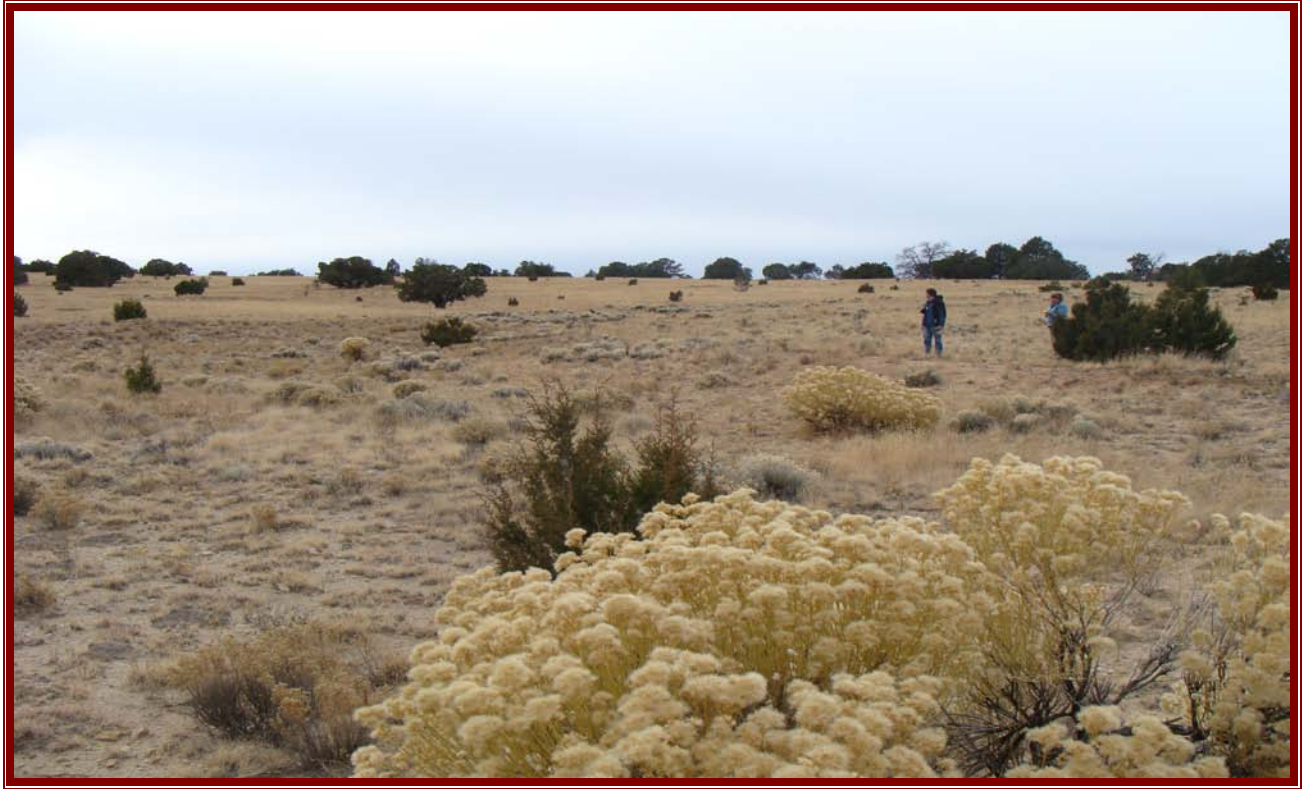
Overall Site Looking West

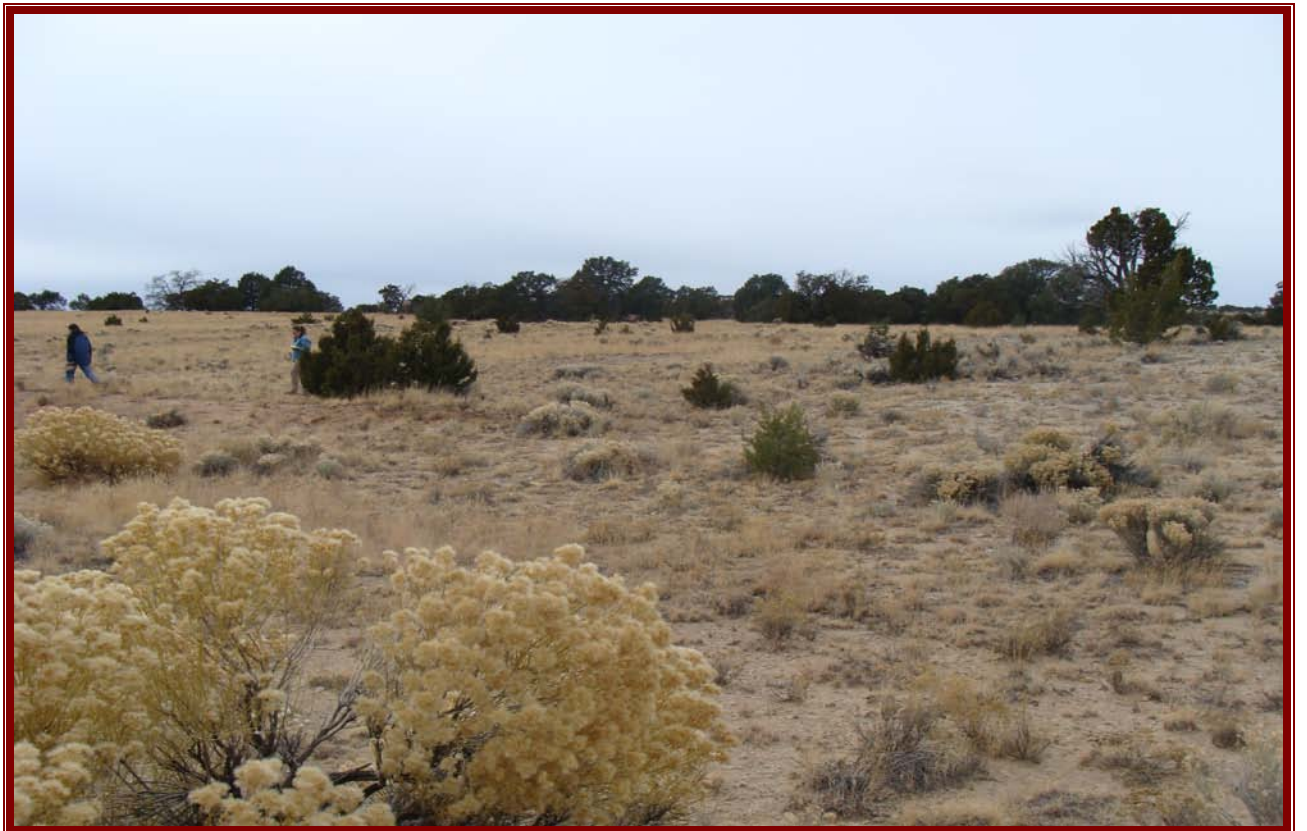
Overall Site Looking Northwest

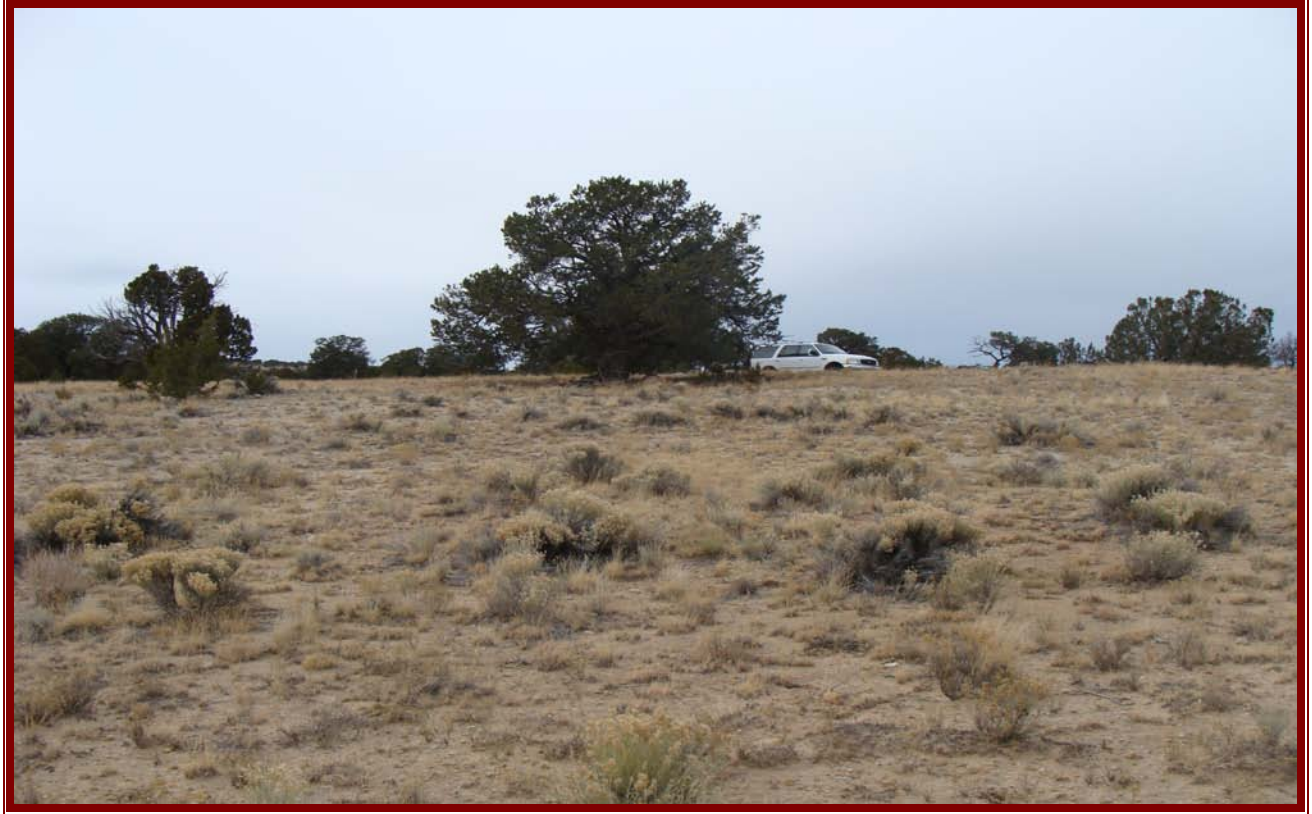
Overall Site Looking Northeast

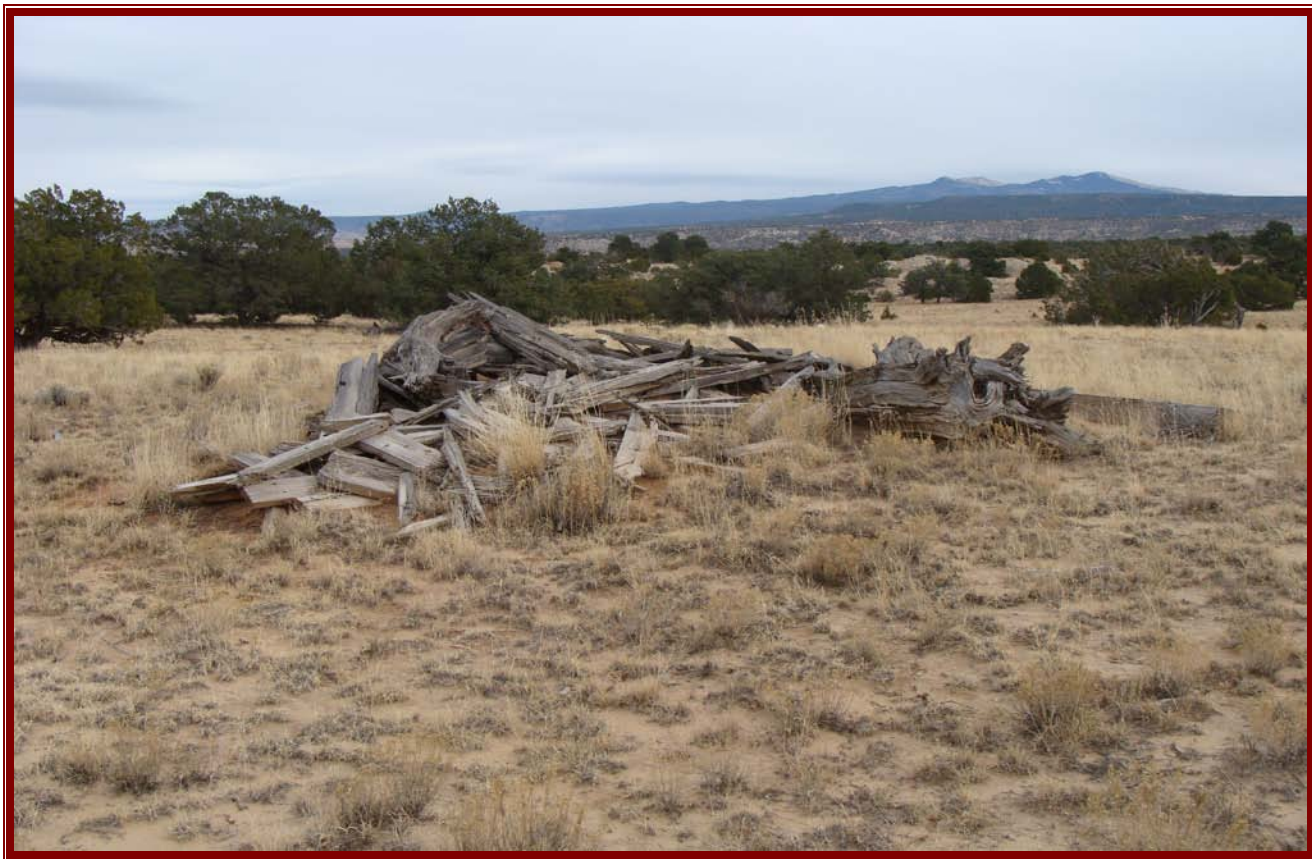
Collapsed Structure Looking East
